MISCELLANEOUS PAPER C-78-4

CONCRETE AND ROCK TESTS
REHABILITATION WORK, BRANDON ROAD
DAM, ILLINOIS WATERWAY
CHICAGO DISTRICT

Richard L. Stowe

May 1978

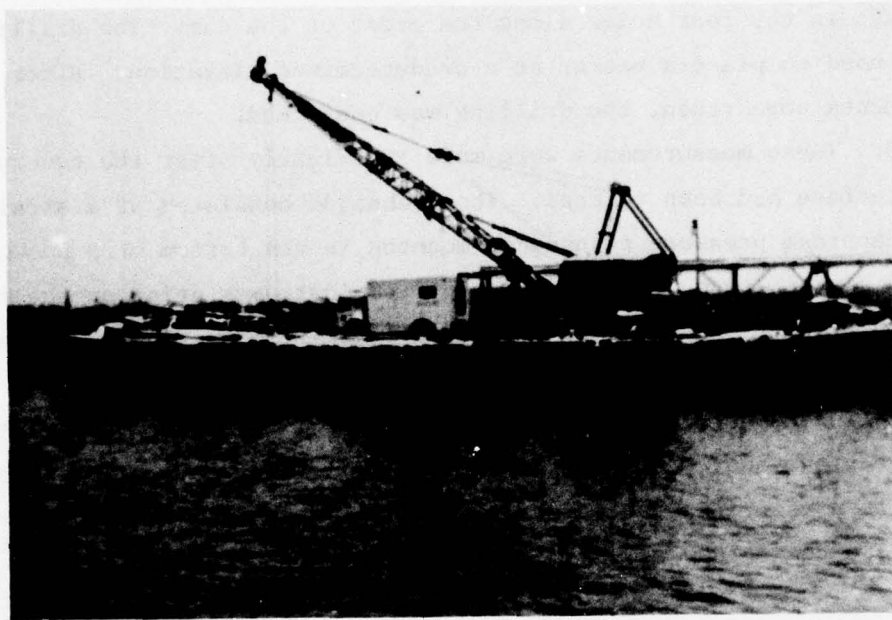
Figure 4. Barge-mounted geophysical truck

21. In the absence of oriented core samples from which the strikes and dips of planar features could be determined, it was decided to use a borehole televiewer logging tool to obtain these structural parameters from the borehole walls. The WES televiewer was run in the four borings across the crest of the dam and in the DS hole, BR WES-6-76. The full depth of the holes was logged, hence information on fractures in the concrete and bedrock was obtained. The televiewer was run in the holes from a geophysical truck that was placed on a floating barge (Figure 4). Cable to the downstream hole was fed through a series of pullies.

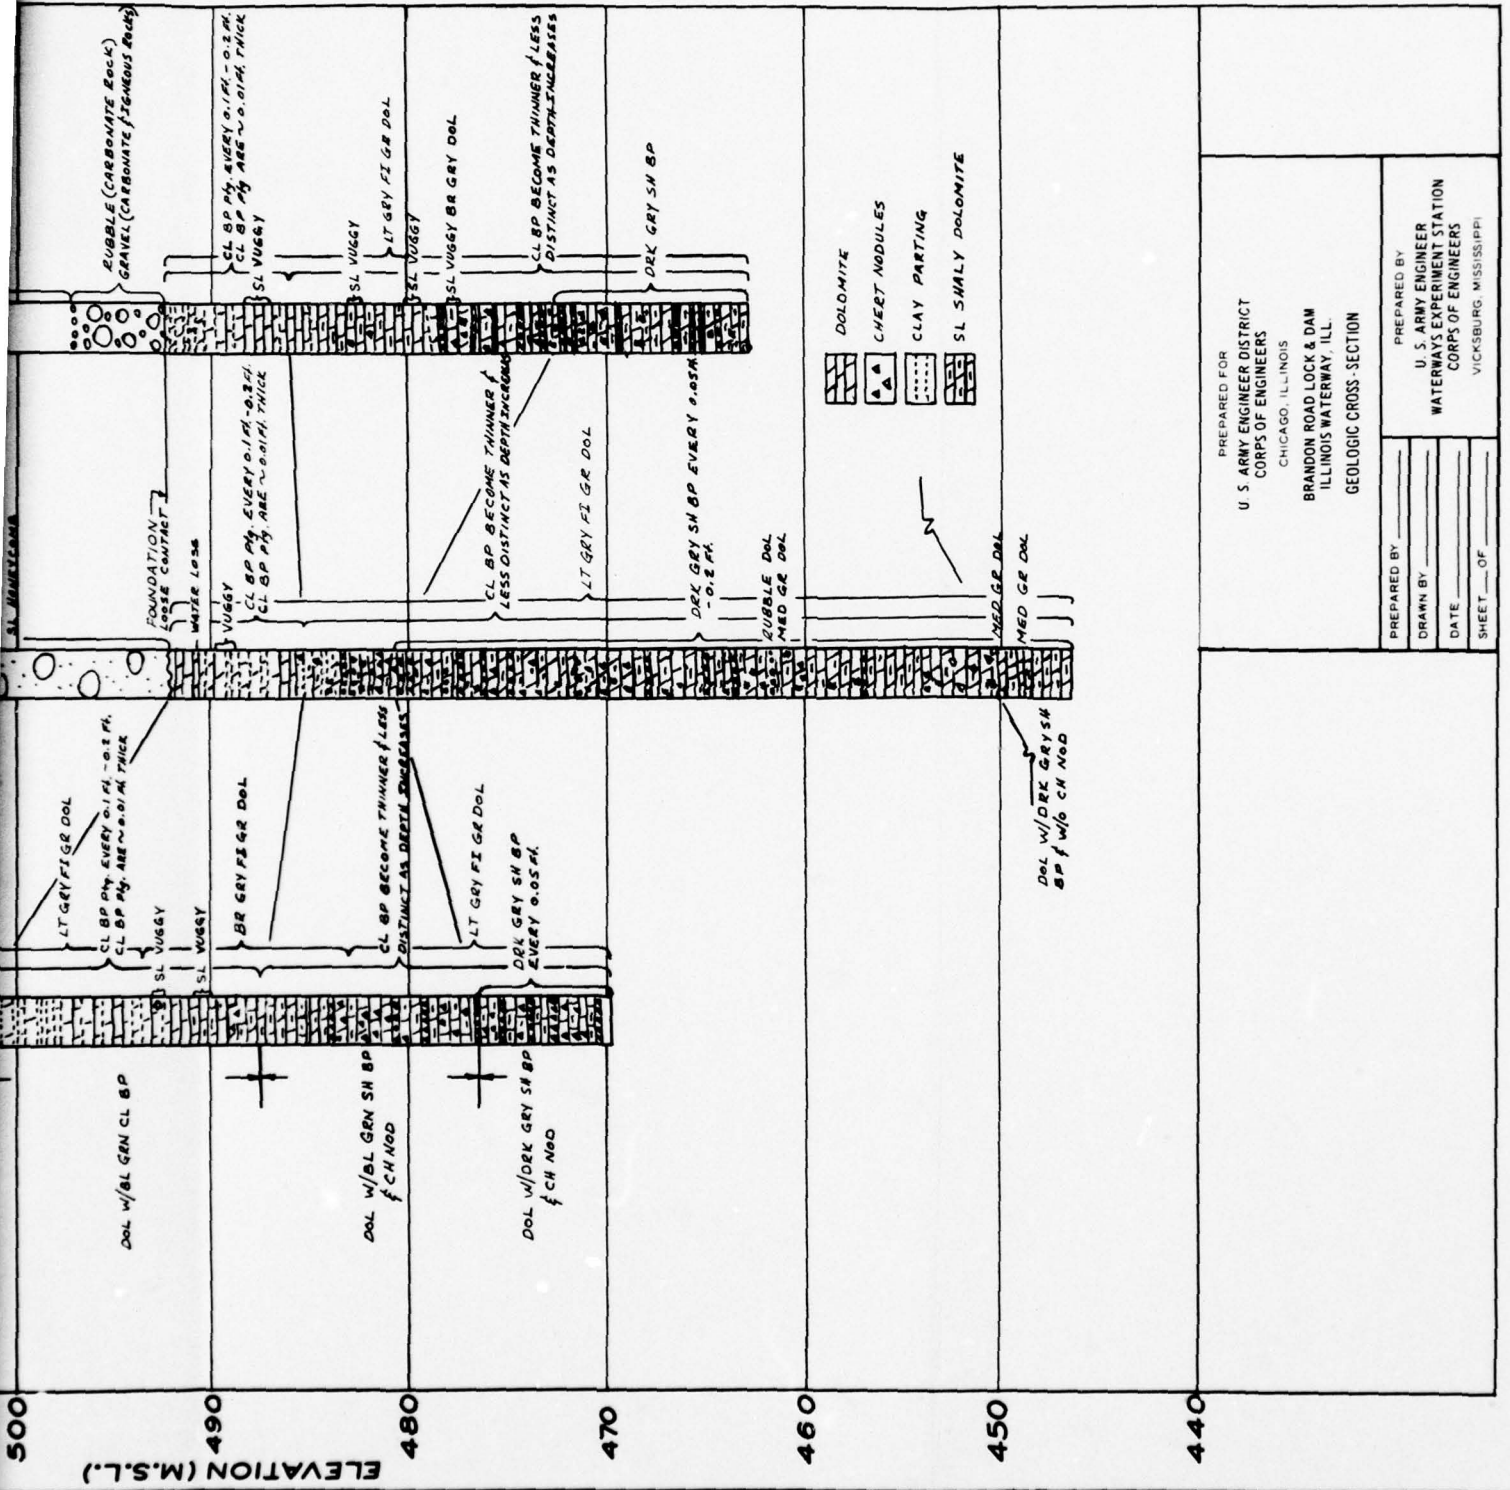
Geologic Cross-Section, Section B-B'

28. The bedrock in sections A'-A' and B'-B' has been subdivided into three units as seen in Plates 5 and 6. The subdivisions were made based upon the color and composition of the filled BP. The units are continuous across the dam foundation and consist of dolomite with the blue-green clay BP, dolomite with blue-green shale BP, and dolomite with dark gray shale BP. The overburden abutting the tainter gates of the dam consists of about 9 ft of organic silt with large amounts of fibrous organic matter and about 6.5 ft of gravel-to-boulder size rock; these depths apply to the area just behind the sluice-gate pier adjacent to tainter-gate 1. The section of silt and gravel is presented in Plate 6.

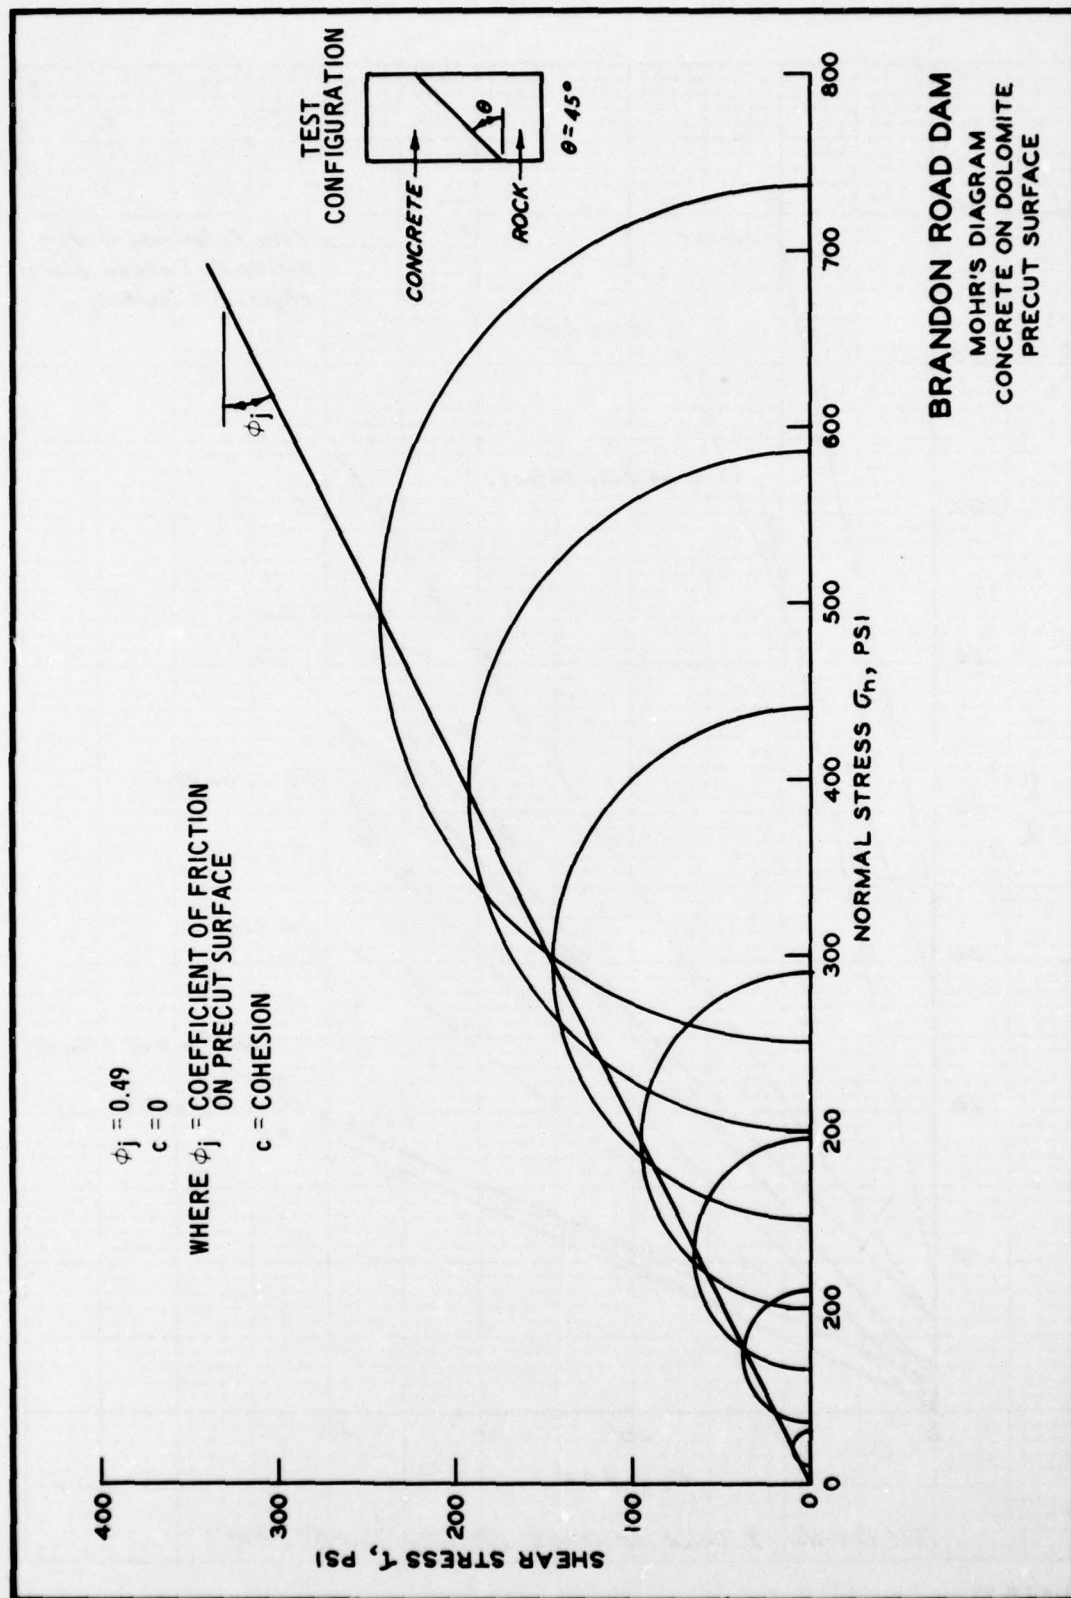
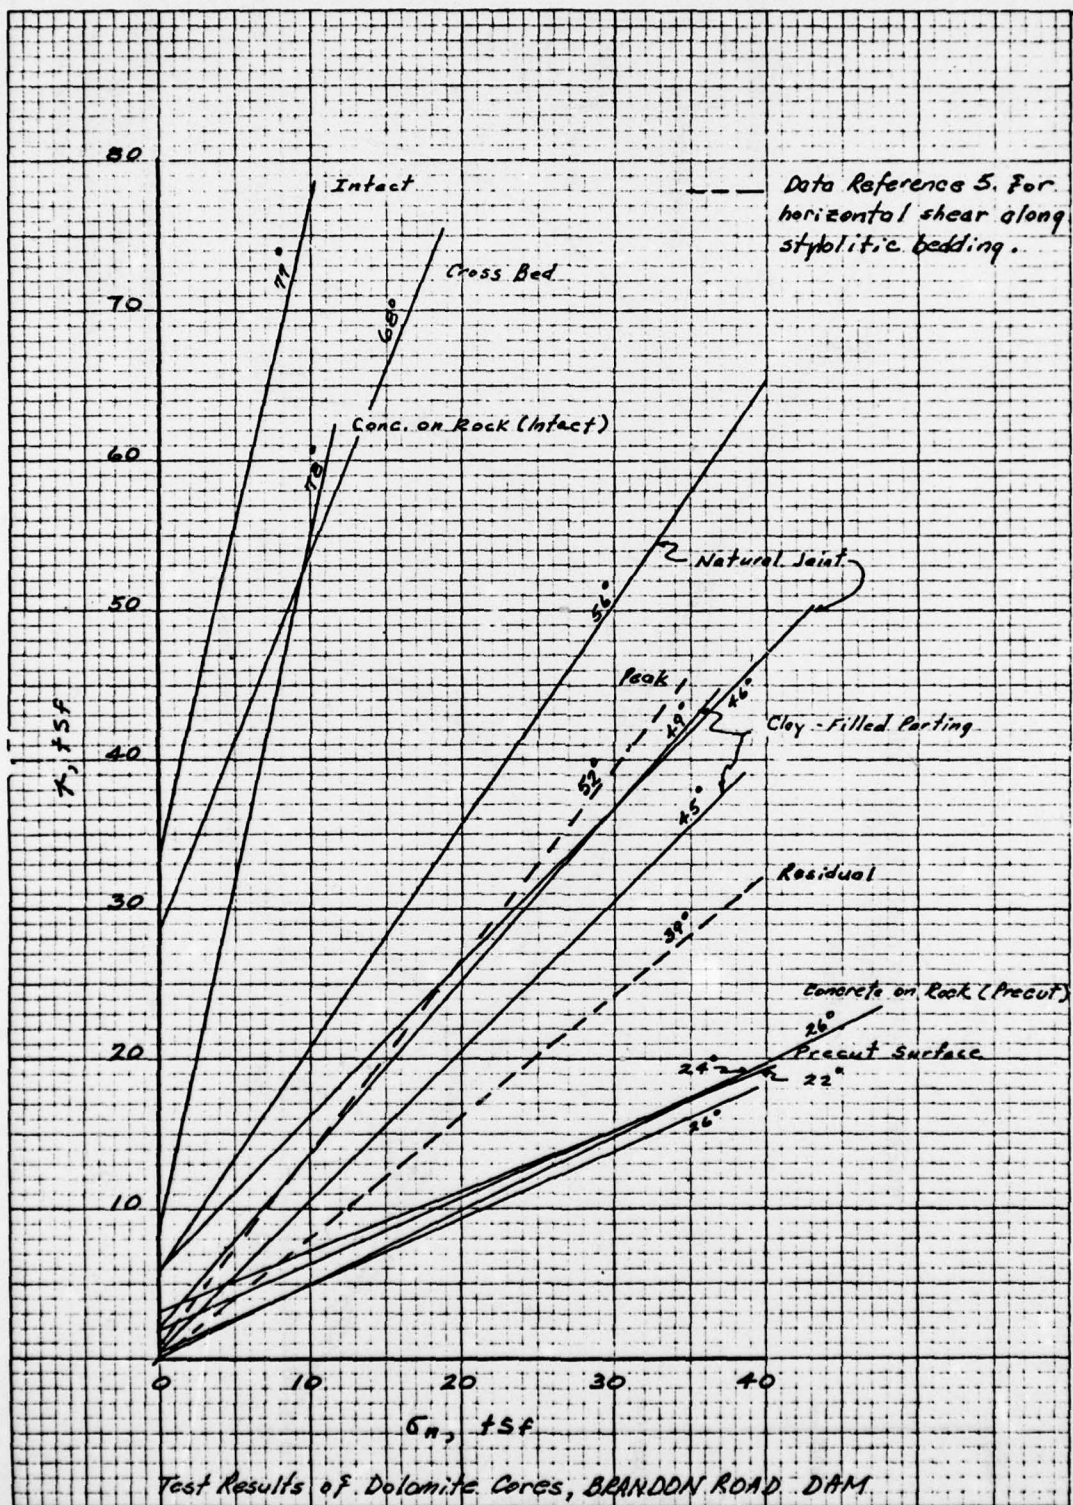
PLATE 32

89. The sliding friction tests were of two kinds: shear of sawed rock surfaces and shear of naturally occurring joints. The respective test results are labeled and presented in Table 6 and Plate 32.

90. From Plate 32 and Table 6, it will be noted that there is a large difference in the angle of friction for the specimens sheared along a natural joint (average $\phi = 51$ degrees) and those sheared along the precut shear plane (average $\phi = 24$ degrees). The surface roughness, about 1/4 in. between peaks and valleys for the specimens tested, accounts in large part for the relatively high ϕ for the natural jointed rock.
